MSAIJ, 6(2), 2010 [120-124]

An investigation on a failed turbocharger turbine blade

Nader El-Bagoury^{1,2}

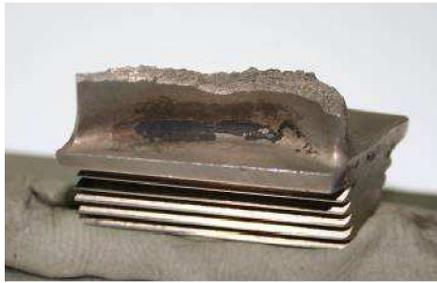
Figure 1 shows a failed blade that entirely sepa-

rated from the airfoil section at a position 12mm away from the platform. The fracture surface of this blade is perpendicular to the longitudinal axis of the turbine blade.

From the above observation, the sequence of the damage for the turboblades starts first with the complete separation of the airfoil part of the blade in figure 1, at 12mm above the platform. This separated airfoil part collided at high speed the other blades in the turbocharger. The fragments, produced from the previous events, with accelerated velocity would hit other blades leading to destruction and deformation of these blades.

Figure 1 : Broken turbo blade

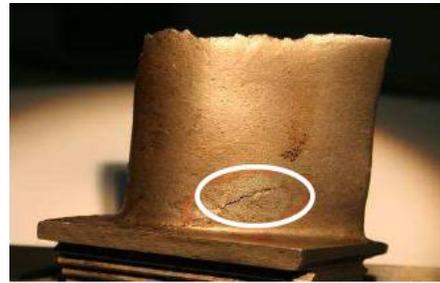
One of the broken turbo blades was found to contain a crack, which was also located at about 12mm above the platform. This crack occurred on the convex side of the airfoil, figure 2. The similarity in the location of the fracture in the blade shown in figure 1 and the crack shown in figure 2 suggests that the turbine blades faced similar conditions which caused the initiation and propagation of the crack.

Figure 2 : Crack starts and propagates at the convex side of the airfoil

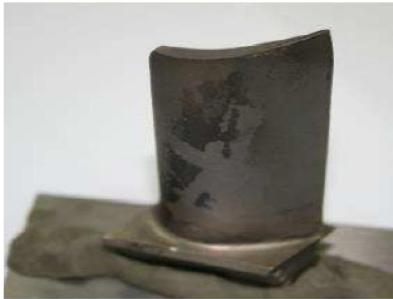
Figure 3 shows a turbine blade broken on the tip at the leading edge, left-upper, of the airfoil. Moreover, the right-upper tip of the airfoil, trailing edge, was deformed. A few turbo blades were found to be completely sound with no signs of any damage.

Figure 3 : Partially broken blade at the tip of the airfoil

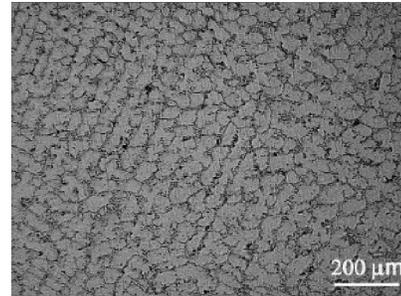
As shown in figure 4, the turbo blade, a cast polycrystalline Ni base superalloy, has a dendritic structure. In this figure, the primary and secondary dendrite arm spacing can be easily recognized.

Figure 4 : Dendritic structure of cast Ni base superalloy

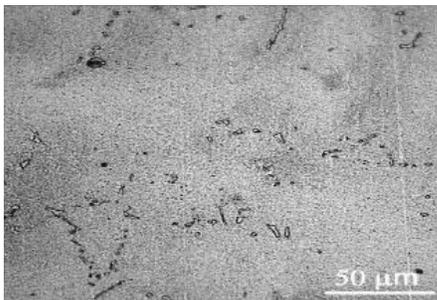
Ni base superalloys are strengthened through the precipitation γ' phase, $Ni_3(Al, Ti)$ in a fcc γ -Ni matrix^[9]. The microstructure of the failed turbo blade is composed of γ nickel-rich solid solution, fine and dispersed γ' precipitates, eutectic γ and carbides, figure 5^[10,11]. This is the ideal microstructure with a fine ordered quasi-cubic precipitate of γ' that should be obtained during manufacture to optimize high temperature strength. Carbides are located in the interdendritic regions in round and plate-like shapes, it can be as well found as a network at the grain boundaries of γ matrix, (Figure 6).

Figure 5 : Microstructure of cast Ni base superalloy

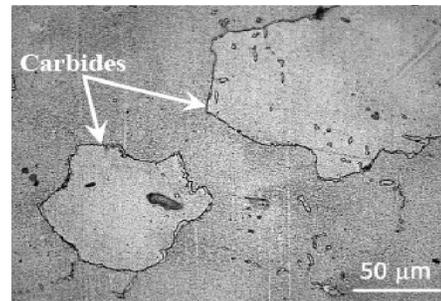
Figure 6 : Carbides network at the grain boundaries of γ matrix

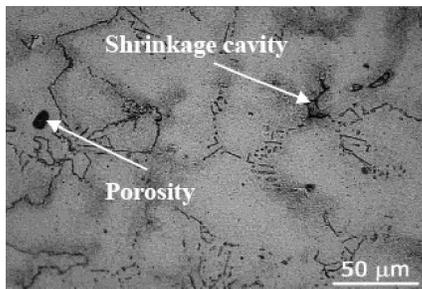
The presence of few porosity and shrinkage cavities in the structure of the unfailed blade can be detected; such defects are unlikely to play a major role in the failure of the blades, (Figure 7).

Figure 7 : Porosity and shrinkage cavity presented in the structure

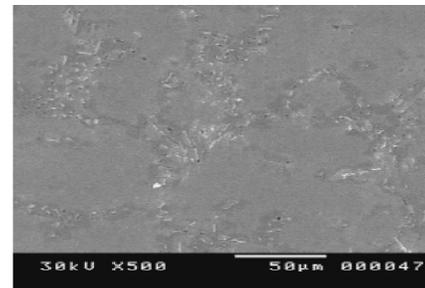
In some interdendritic regions, a high density of plate-like carbides was found, figure 8. These carbides, analyzed by using EDS, were found to consist of Mo, Cr and Ti.

Figure 8 : High density of carbides in interdendritic regions

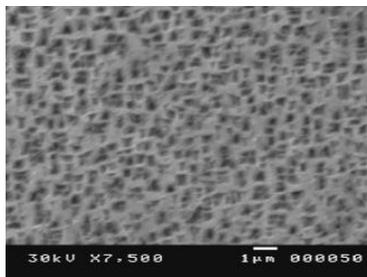
Figure 9 shows the γ' precipitates in γ matrix at the root of the platform section which represent the cold reference zone. The root of the blade is considered as "cold or reference zone" as it is not exposed to the hot combustion gases and microstructural changes are not considerable^[12]. Most of γ' precipitates in blade's root are cubic morphology with average cubic edge about 0.45 μ m.

Figure 9 : γ' precipitates in γ matrix at the root of the platform section

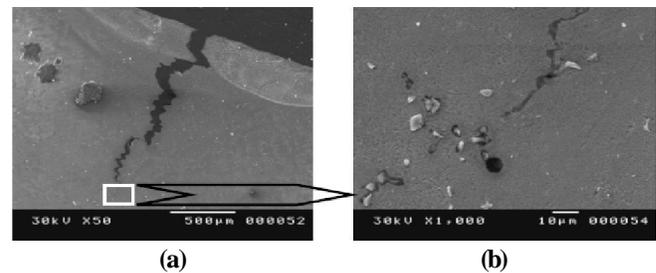
As shown in figure 10(a) and 10(b) the crack starts on the convex side (suction side) and propagates towards the concave side (pressure side) perpendicular to the blade vertical axis following the degraded structure in interdendritic regions and grain boundaries.

Figure 10 : (a) Crack starts at the convex side of the blade, (b) Crack propagates through the interdendritic region

When gases flowed into concave side of the blade through the leading edge, the surface of the concave side of the blade was subjected to bending tensile stress and hence crack can easily initiate at this region.

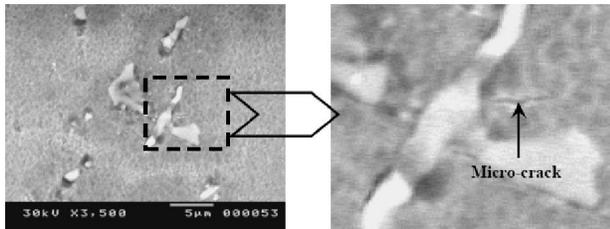
Figure 13 : Micro-crack starts at interdendritic zone

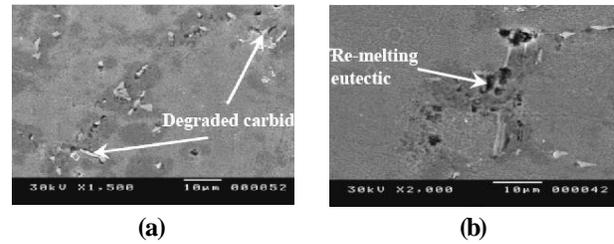
It is also noted that, some positions in the interdendritic zones were found open as it can be seen in figure 12(a). Moreover, a localized re-melting of eutectic at higher magnification was revealed as well, figure 12(b), leading to degradation of the microstructure and initiation of micro-cracks from the interdendritic regions^[13,14]. Micro-cracking preferably occurred in interdendritic regions and the cracks propagated within the interdendritic region to form short cracks on the airfoil surface, figure 13.

- 3 Typically over-heat structure damage had taken place due to localized remelting of the eutectic structure of the failed blades. It is suggested that the operating temperature of the blades had exceeded the specified one leading to over-heat damage.

Figure 12 : Re-melting of eutectic γ/γ' and degraded carbide in interdendritic regions

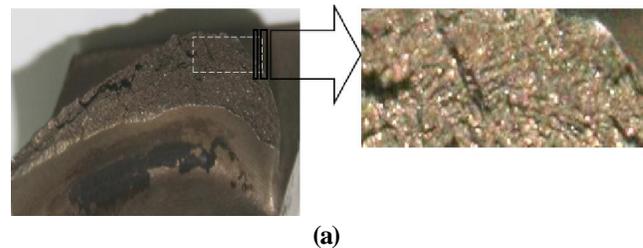
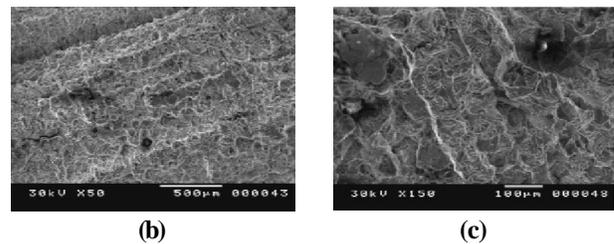
The fracture surfaces of the failed blade were observed in detail. Beach marks and tear ridges can be found on the fracture surface as shown in figure 14^[15-17].

Presence of the over-heat damage structure would considerably decrease fatigue strength of the blade.

- 4 In addition to overheating, fatigue cracking is the prevailing mechanism for the occurrence of the fracture failure in airfoil section.
- 5 Micro-cracking is initiated in interdendritic regions due to strength reduction because of over-heating. Under centrifugal, vibration and bending stresses, the micro-cracks propagated within the interdendritic region and formed short cracks in the airfoil section. The nearby short cracks with identical orientation converged to form long cracks, and

Figure 14 : Fracture surface of the failed blade
